## Saab – SF340A, VH-LPI Eildon Weir, Victoria

AIR SAFETY INVESTIGATION

199805068

**Saab – SF340A, VH-LPI**  
**Eildon Weir, Victoria on 11 November 1998**

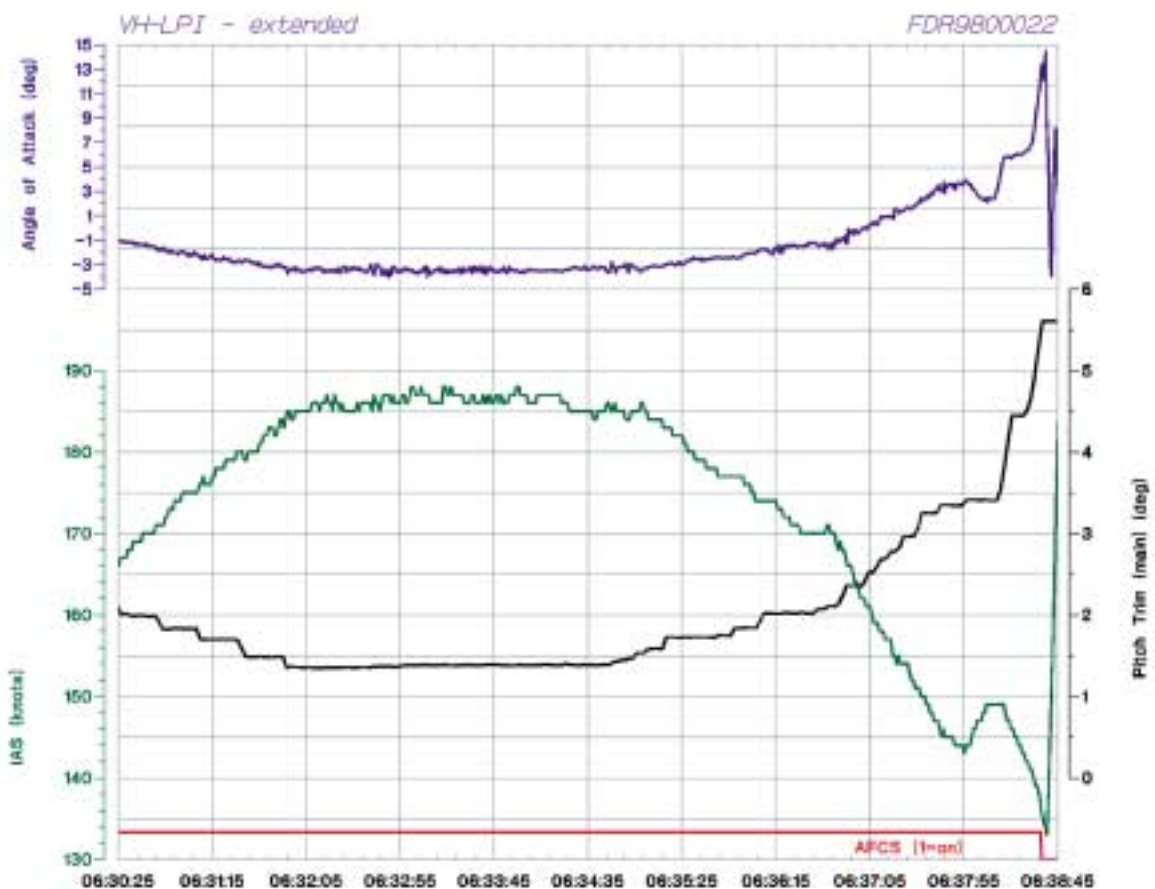
In this occurrence, analysis of the recorded data showed that as the aircraft speed decreased, the autopilot commanded an increasing amount of nose up elevator to maintain altitude. Commensurate with this, the trim was also progressively increased nose up by the autopilot. For further information on recorded data refer to section 1.11 of this report.

**FIGURE 1:**  
Shows the movement of the pitch trim in the time leading up to the occurrence.

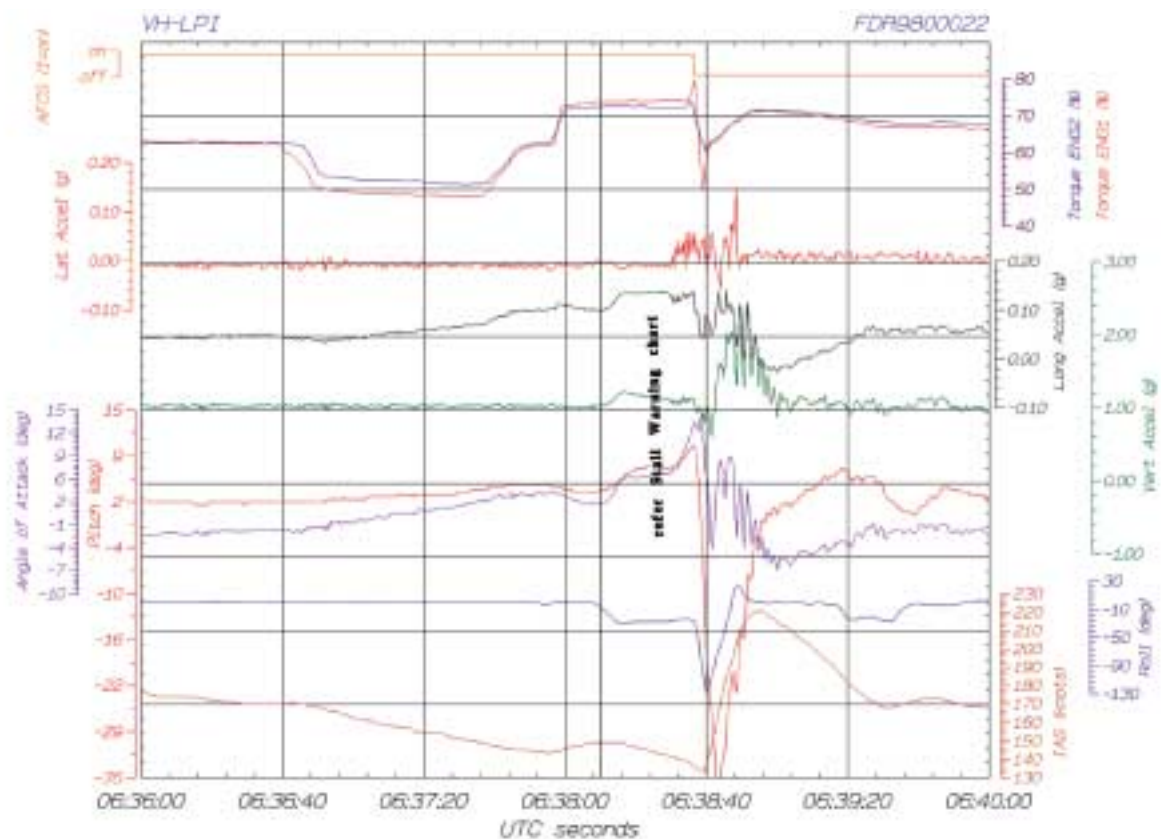
Figure 2 shows a graphical representation of the recorded values of indicated airspeed, pitch, roll, angle of attack, vertical, longitudinal and lateral accelerations, engine torque and autopilot setting in the time leading up to the occurrence and immediately after it.

**FIGURE 2:**  
**Recorded values**

At 06:29:15 the aircraft reached the top of climb at FL 150. The recorded torque value was 63%. The aircraft remained in this configuration until 06:36:38 when the torque was reduced to 47%. The angle-of-attack before the reduction of the torque was  $-1.4$  degrees. The reduction in torque occurred over 12 seconds. The indicated airspeed at the beginning of the reduction was 170 KIAS. At 06:37:36, when the airspeed was 149 KIAS, the torque increased to 62%. The increase in torque took 14 seconds. The airspeed continued to decrease until 06:37:50 when it reached 144 KIAS, where it remained constant for

8 seconds. At 06:37:56 the torque was increased to 74% over 5 seconds. The airspeed began to increase at 06:37:58 and reached 149 KIAS at 06:38:07. The aircraft began a left-hand turn at 06:38:08, with a recorded bank angle of 28 degrees. The indicated airspeed remained at 149 KIAS. The recorded angle-of-attack then was 4.5 degrees.

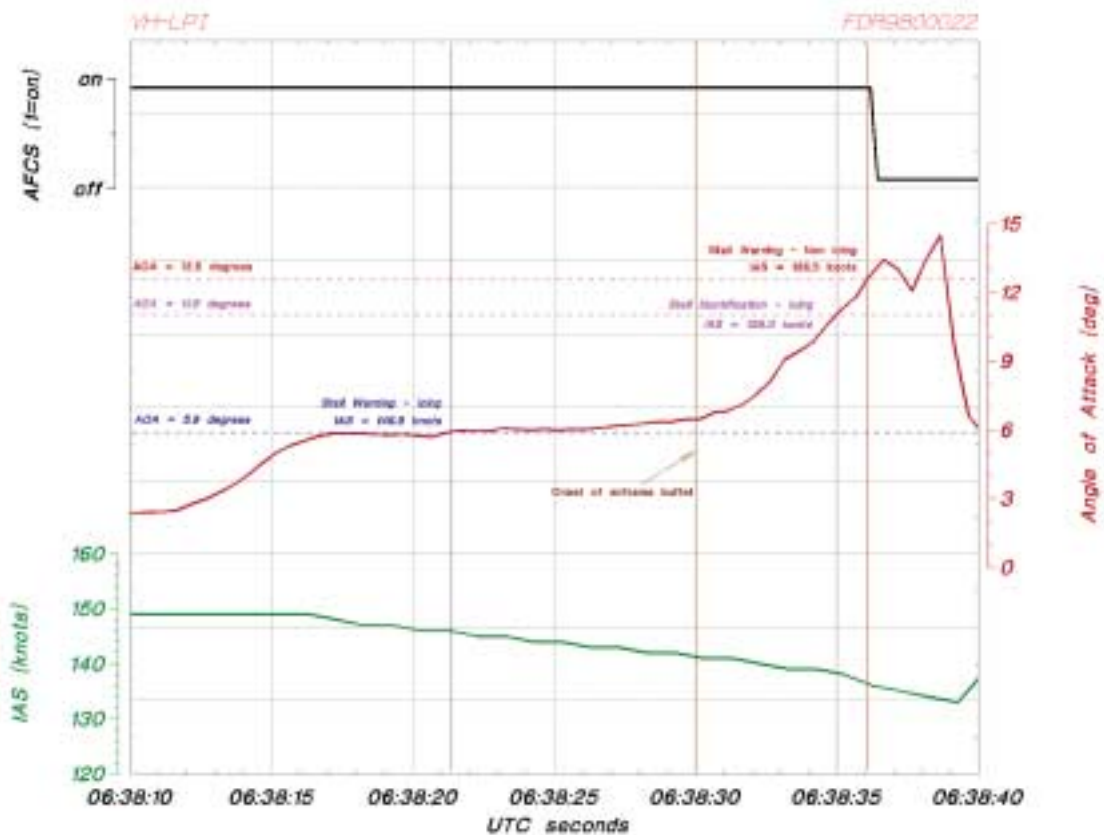
**FIGURE 4:**  
**Analysis of stall event and application of Canadian stall warning parameters**
